**SITE ASSESSMENT REPORT  
FOR THE  
EUCLID TOWNHOMES SITE  
DETROIT, WAYNE COUNTY, MICHIGAN**

Date Prepared:	November 17, 2010
Technical Direction Document No.:	S05-0001-1005-037
Document Control No.:	1069-2A-AHLC
Contract No.:	EP-S5-06-04
WESTON START Project Manager:	Lori Kozel
Telephone No.:	(248) 658-5012
U.S. EPA On-Scene Coordinator:	Tricia Edwards

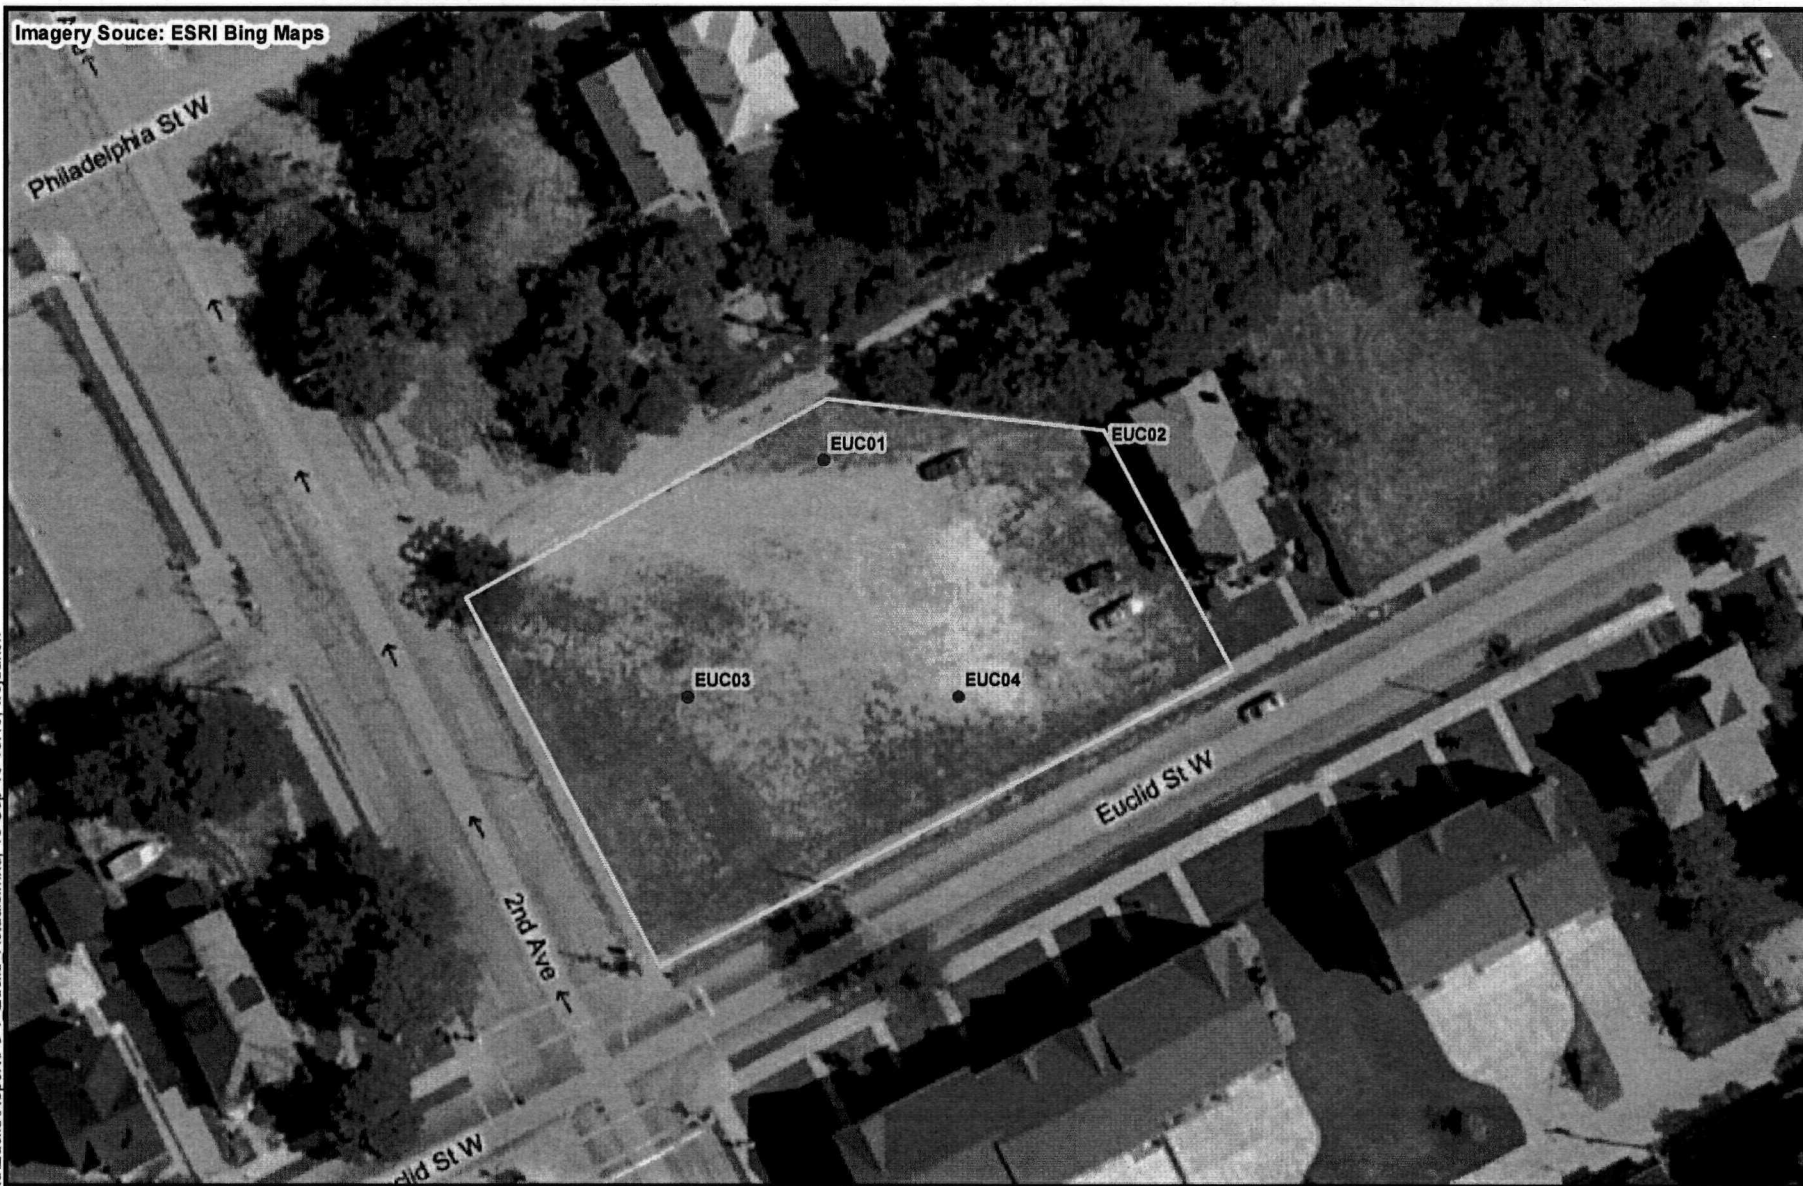
**Figure 3-1**  
Sampling Location Map  
Euclid Townhomes SA  
Detroit, Wayne County, Michigan

During the SA, WESTON START performed XRF screening for selected metals of surface soil throughout the Site using an Innov-X XRF analyzer. **Figure 3-1** shows the screening locations. WESTON START used the sampling design generated for the Site by the VSP software to identify the XRF screening and potential sampling locations. The VSP software identified 4 screening locations to locate a hotspot with a 50-foot-radius with a 95 percent probability. The VSP software provided coordinates for each location and the points were evenly distributed across the Site. The XRF analyzer was used to screen the surface soil at each pre-determined location. Where required, surface vegetation was removed to create a flat surface to collect accurate XRF readings.

One additional screening location was added to the property at the discretion of the OSC. A random point was chosen within the bike path crossing the property, XRF screening was performed, and the location of the screening point was collected using GPS.

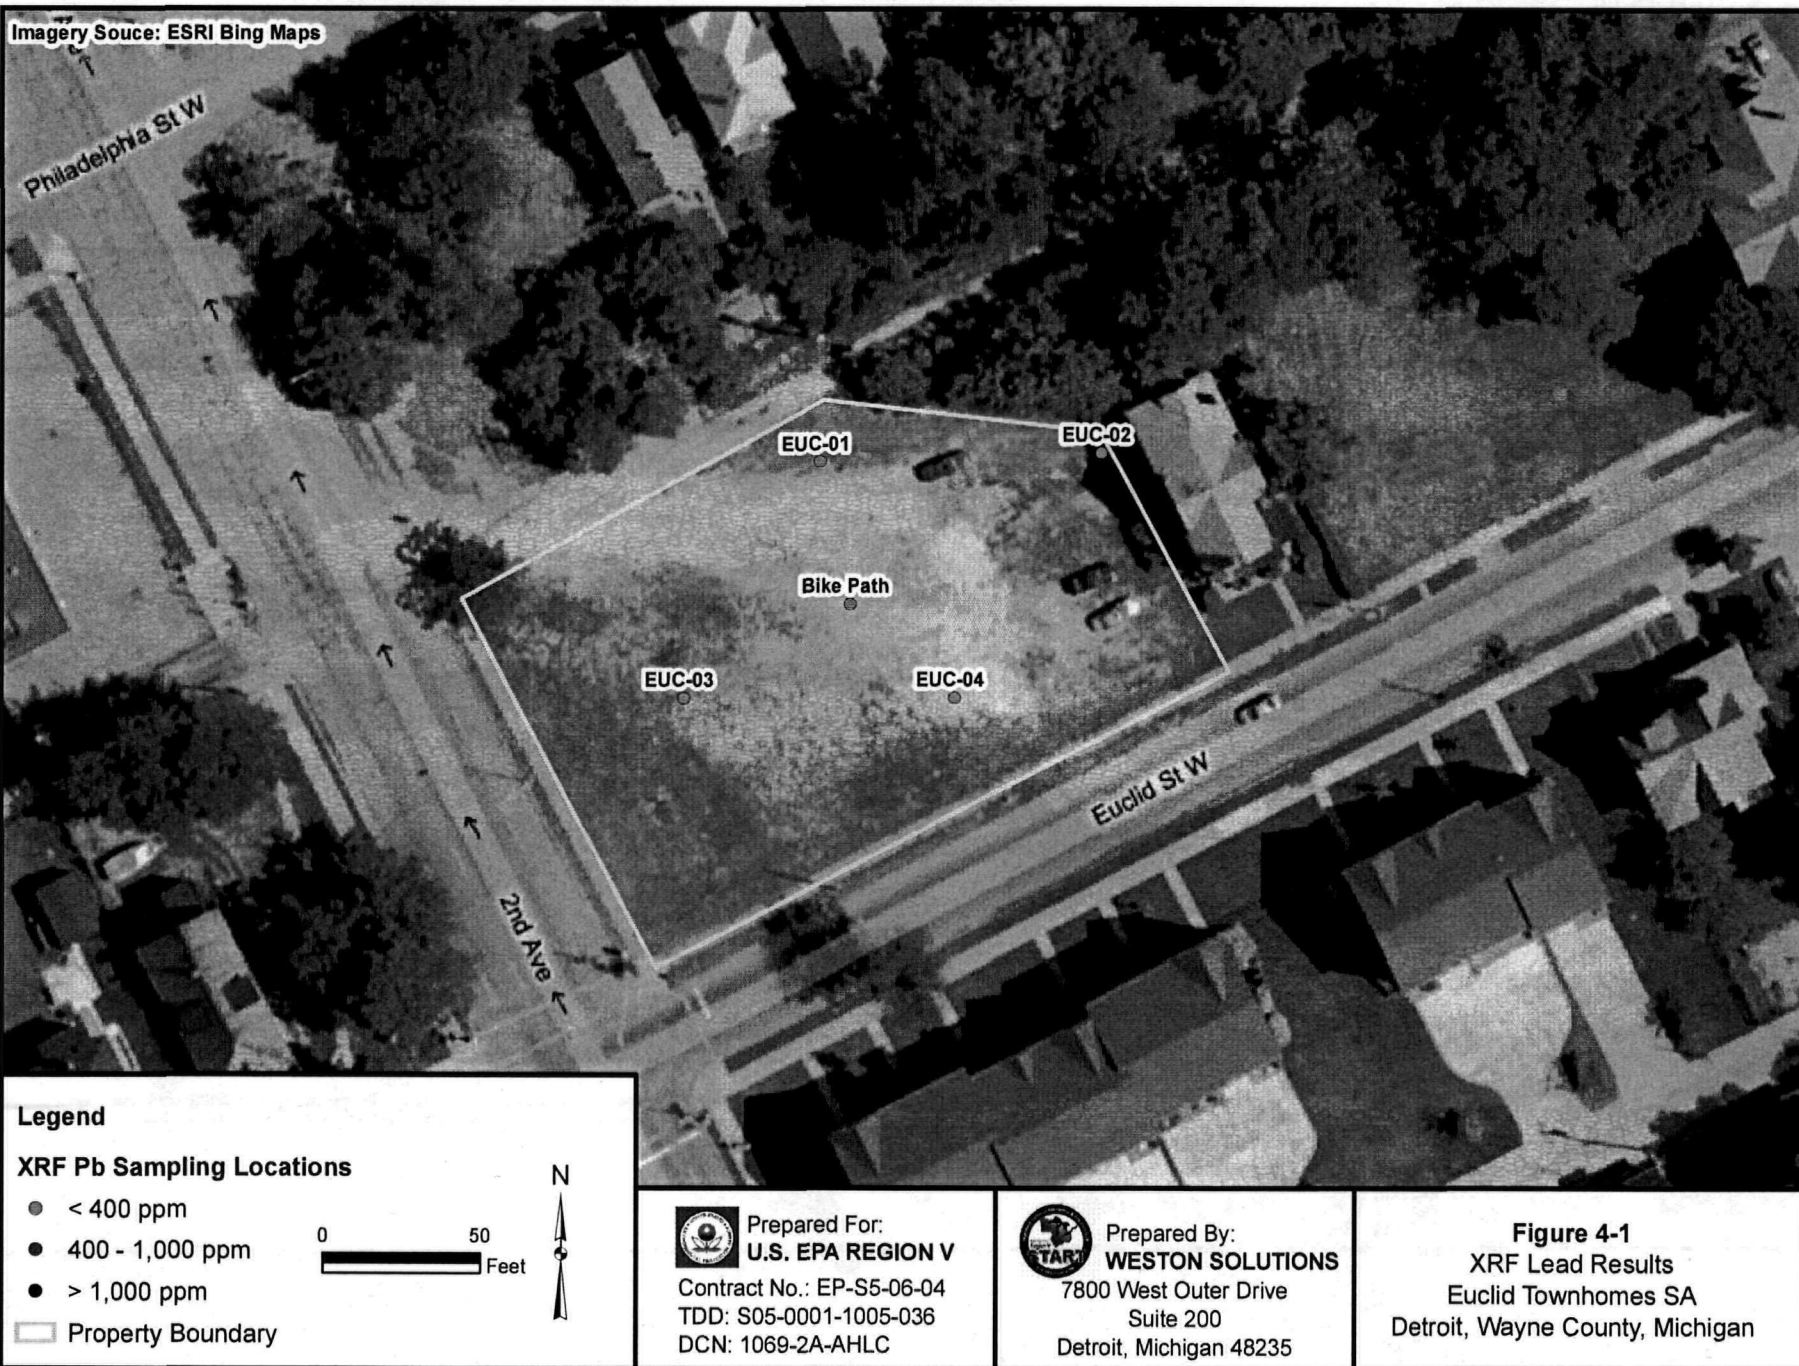
**Table 4-1** summarizes the XRF results for the 5 XRF screening locations, and **Figure 4-1** summarizes the XRF lead screening results. The XRF analyzer provides results for 21 metals and typically is used for lead assessments. Historical data evaluations support the correlation between actual sample data from the laboratory and XRF field screening results. For this SA, WESTON START focused on the lead and arsenic concentrations in surficial soils. Both lead and arsenic contamination typically are of concern in industrial areas in the City of Detroit.

The XRF lead screening results ranged from 42 to 135 parts per million (ppm), with the highest result detected at EUC-02. According to the Michigan Department of Natural Resources and Environment (MDNRE) Part 201 - Residential and Commercial I Direct Contact Criteria, a total lead value in soil exceeding 400 ppm and a total arsenic value exceeding 7.6 ppm present a direct contact risk. No XRF screening locations (1) exceeded the lead value of 400 ppm or (2) exceeded the arsenic value of 7.6 ppm. The XRF results also were compared to the State of Michigan Default Background levels; of which iron, lead, and zinc results exceeded the background levels but were below the MDNRE Part 201 Residential and Commercial I Direct Contact Criteria.

Based on the XRF readings, no locations exceeded the MDNRE Part 201 - Residential and Commercial I Direct Contact Criteria for either lead or arsenic. The XRF results were compared to the State of Michigan Default Background levels; of which iron, lead, and zinc results exceeded the background levels but were below the MDNRE Part 201 Residential and Commercial I Direct Contact Criteria. The XRF readings were below hazardous levels, and the screening locations were covered with vegetation at the time of sampling. The focus of this SA was surface soil and potential metals contamination only. A thorough historical review of the

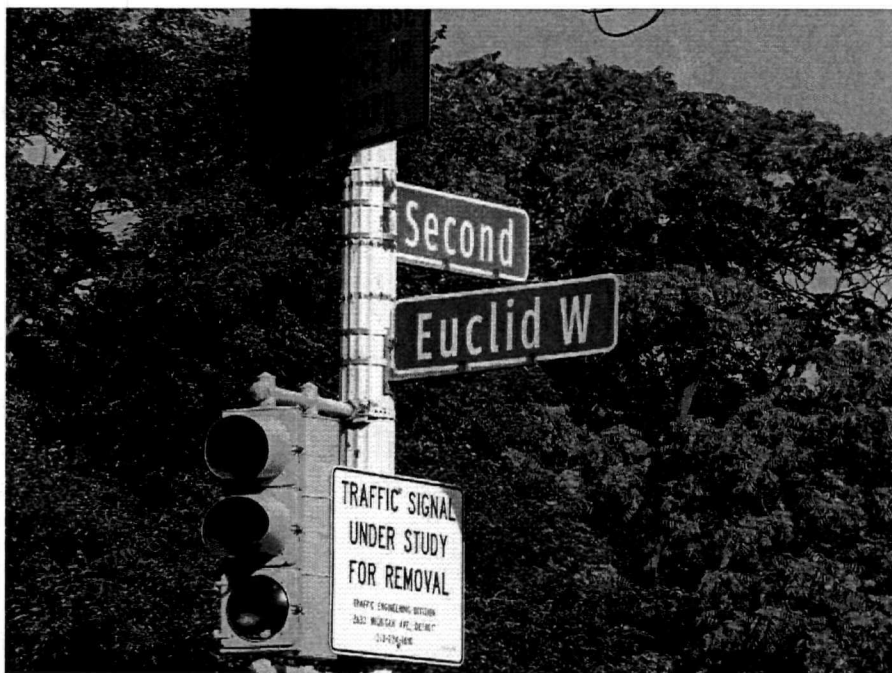
**Photograph No.:** 1

At the time of the SA discussed in this report, the Site was a vacant parcel with overgrown vegetation and no buildings. A bike path was observed crossing from the northwest to the southeast corner of the property. The Site had no perimeter fencing or obstructions to deter people or wildlife from entering the property. No hazards were identified during SA activities.

**Subject:** Site located at the northeast corner of Second Street and West Euclid Street

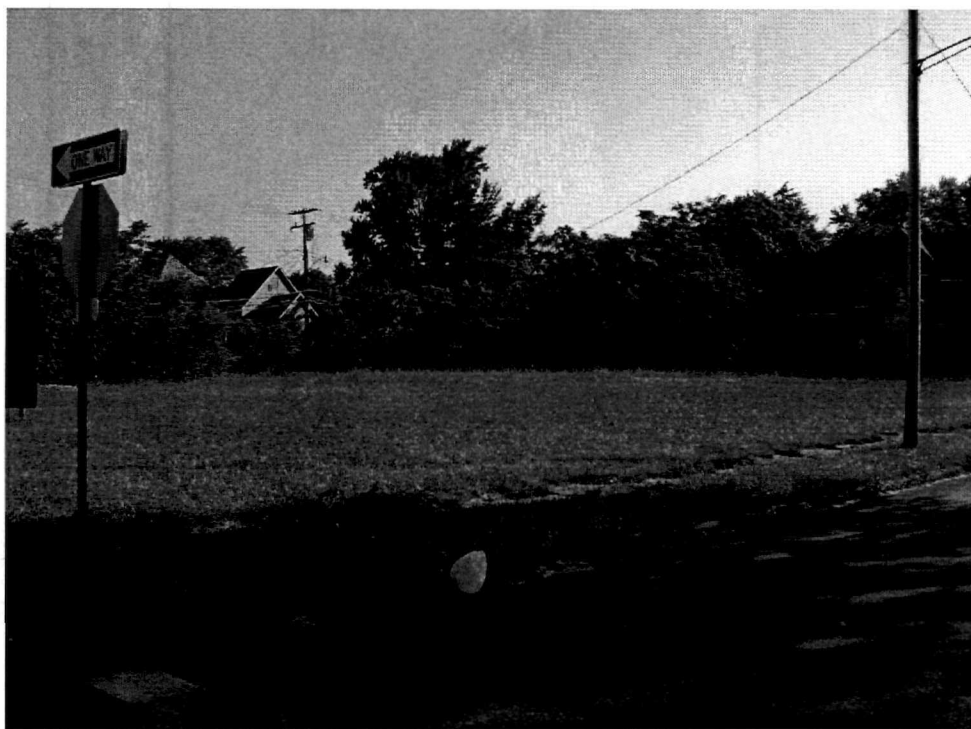
**Photograph No.:** 2

**Subject:** Northwest view of the Euclid Townhomes Site

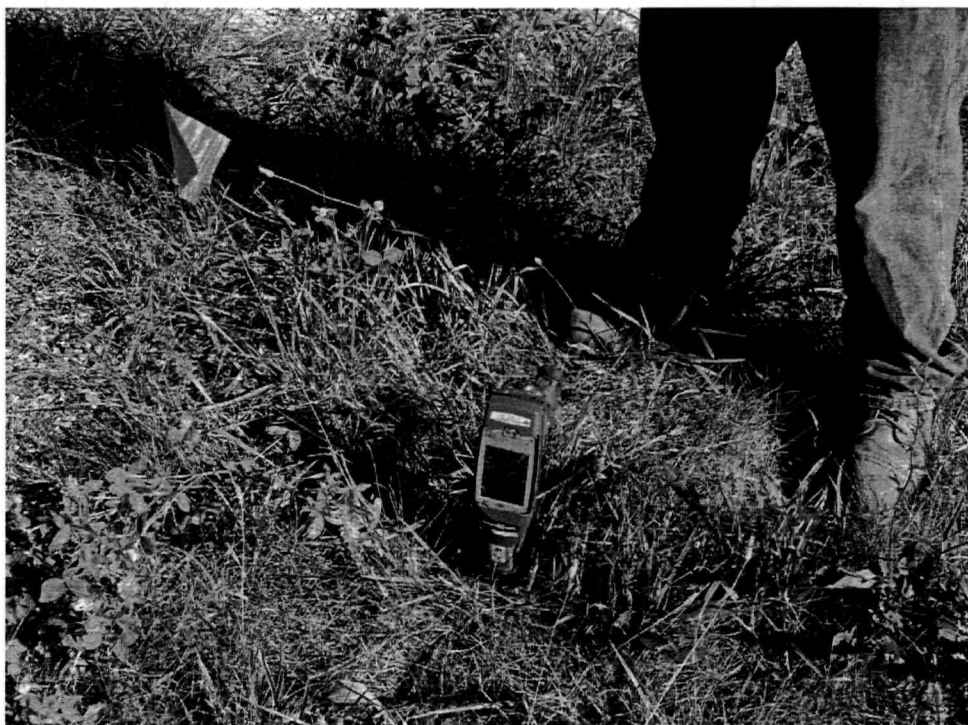
**Photograph No.:** 3

**Subject:** X-Ray Florescence (XRF) screening of surface soils
